DAF WHEEL HUB REBATE CRITERIA

— APPROVED & REJECTED CONDITIONS GUIDE —

STANDARD DISC TYPE FRONT & REAR WHEEL HUBS

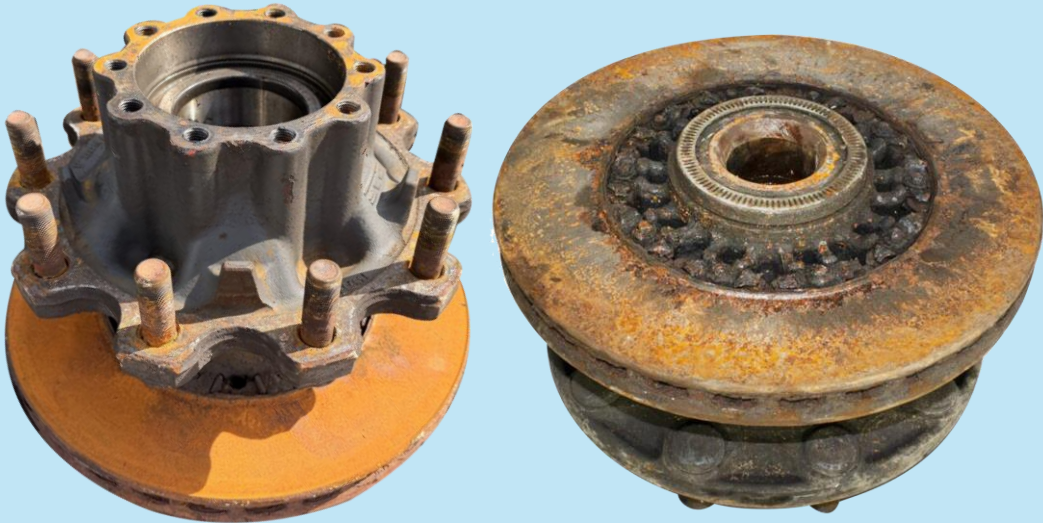
Complete hub kit

- Brake disc fitted
- Hub cap attached
- ABS ring fitted
- Wheel nuts attached
- Wheel studs fitted

APPROVED! ✓

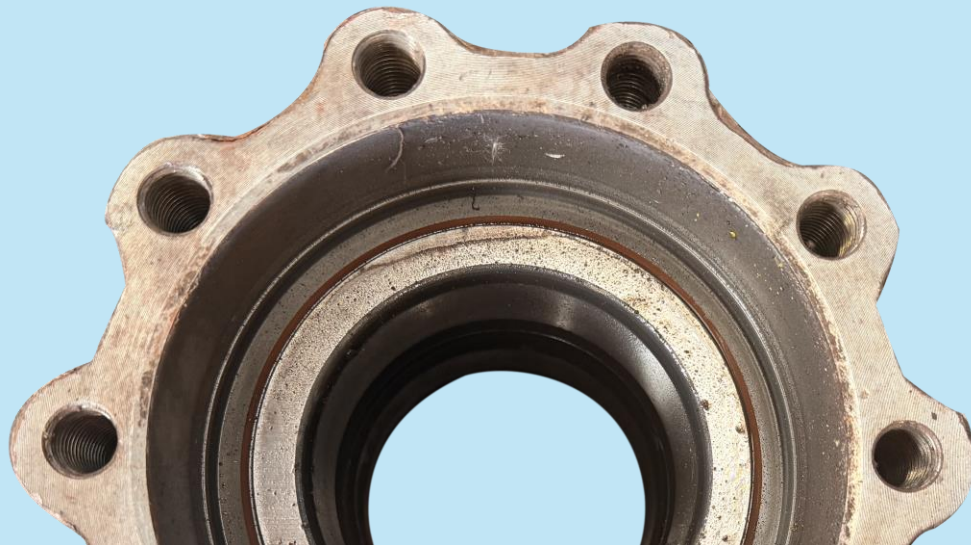
HALF SHAFT SEATING AREA:

Small / light scuffs & marks

Clean & undamaged surface

APPROVED! ✓

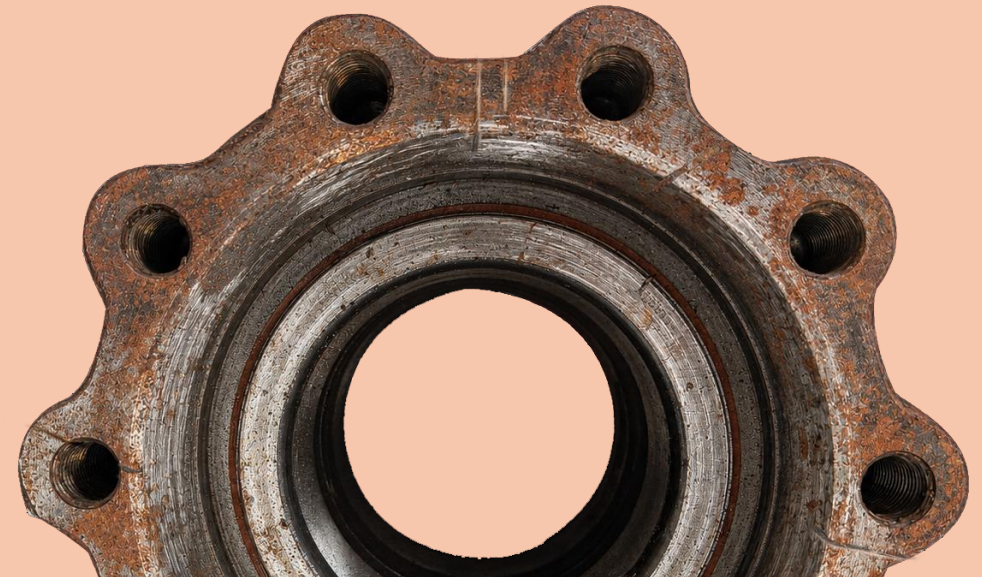
- Surface deformities in the seating area

- Gouges in or around the seating area

NOT APPROVED! ✗

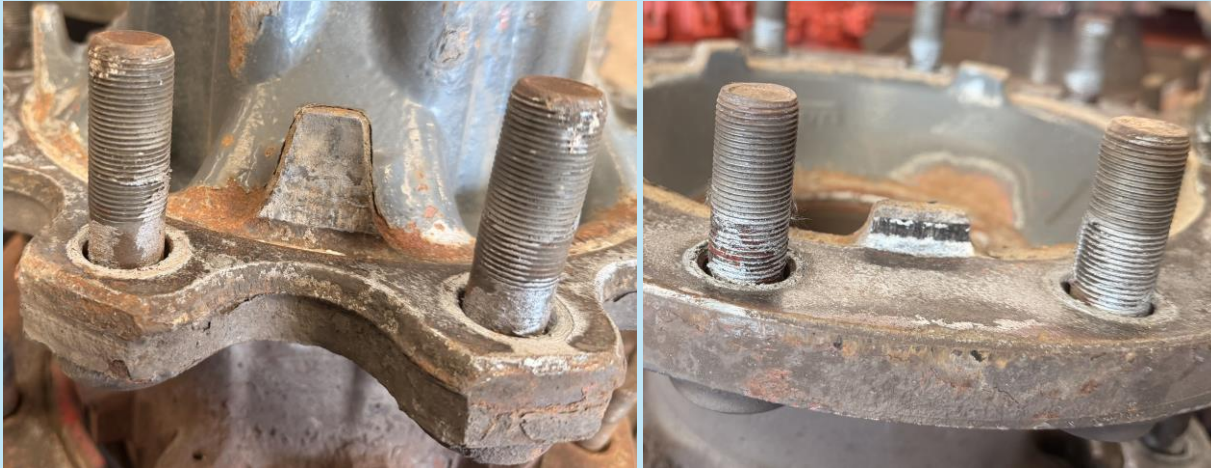
WHEEL LOCATION SPIGOTS CRITERIA:

- Rust/Corrosion build-up
- Small indentations

APPROVED! ✓

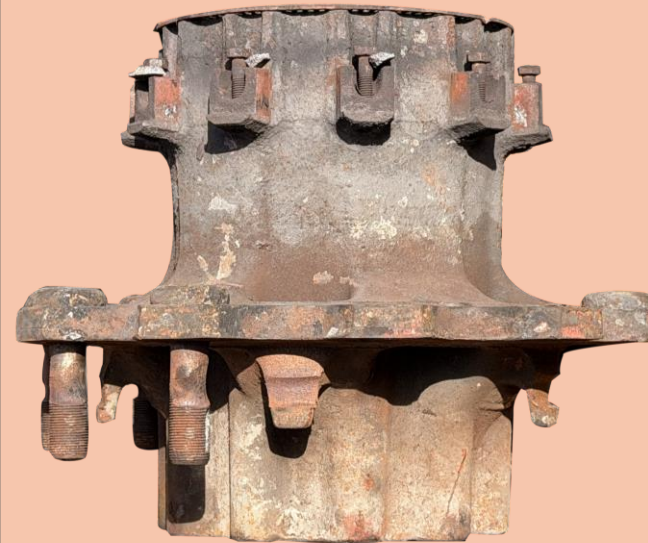
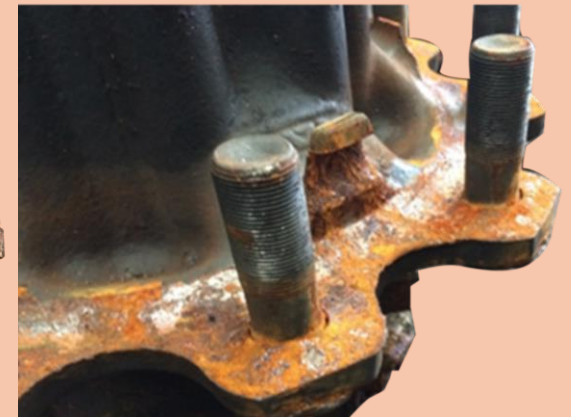
- Damaged caused by a loose wheel
- Sheared spigots

NOT APPROVED! ✗

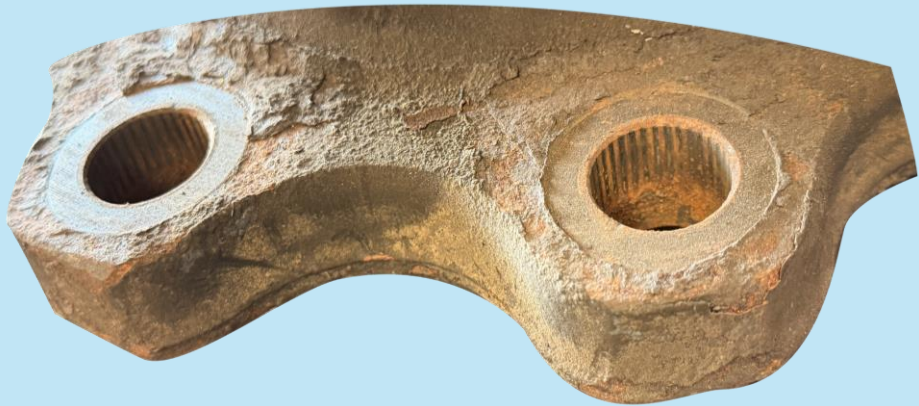
WHEEL STUD HOLES CRITERIA:

Circular indentations

Rust/corrosion build-up

APPROVED! ✓

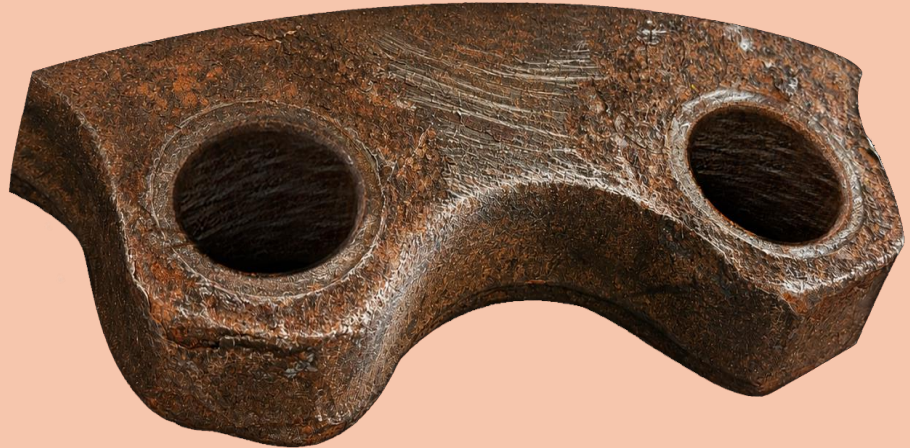
- Damage caused by a spun wheel stud

- Gouges in or around the wheel stud hole

- Wheel stud hole deformities

NOT APPROVED! ✗

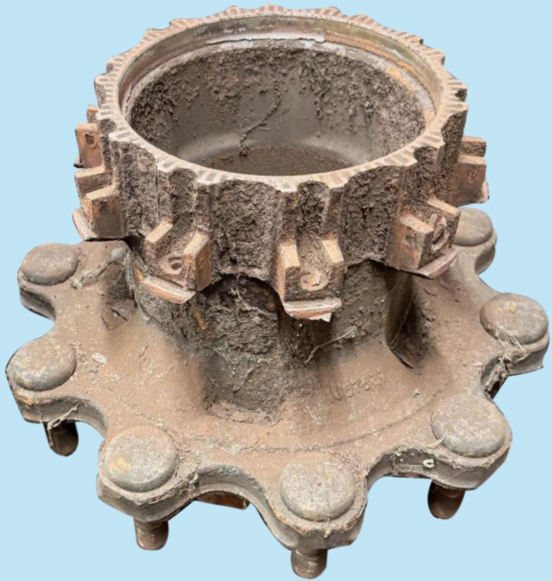
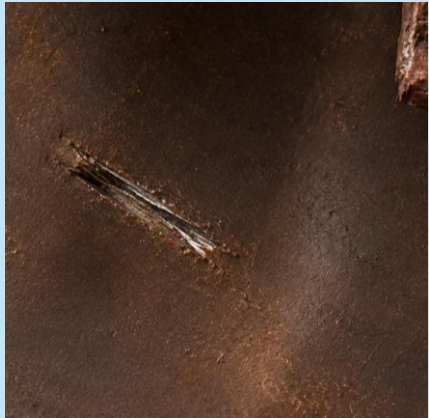
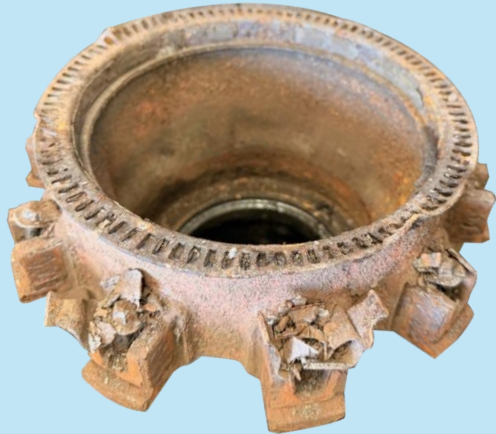
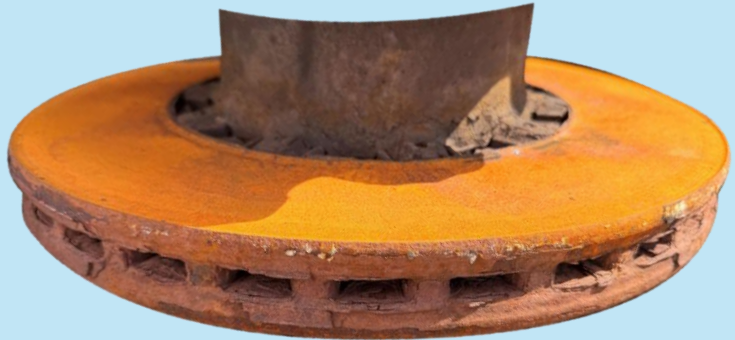
GENERAL WEAR & TEAR CRITERIA:

- Rust , Dirt, Corrosion build-up on the casting

- Slightly loose brake disc

- Small indentations on the hub casting

- Worn or damaged ABS ring

- Worn or damaged brake disc

APPROVED! ✓

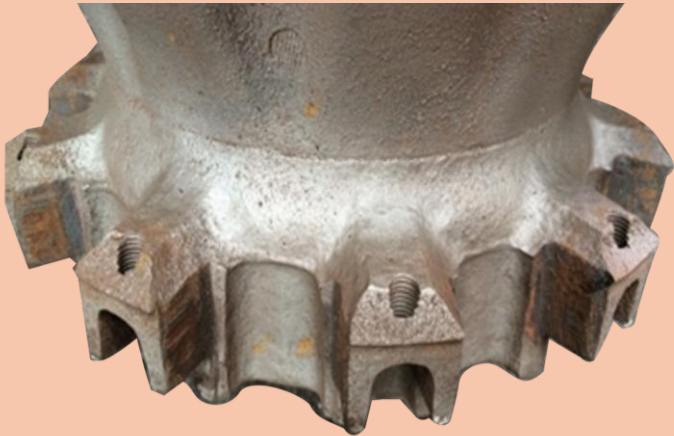
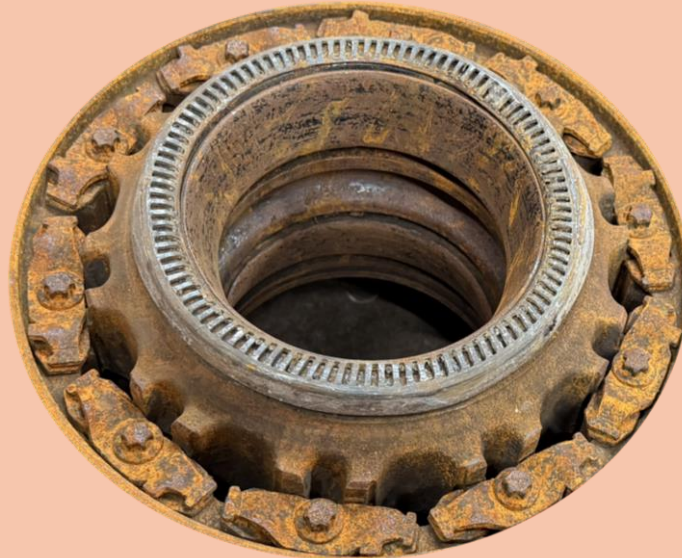
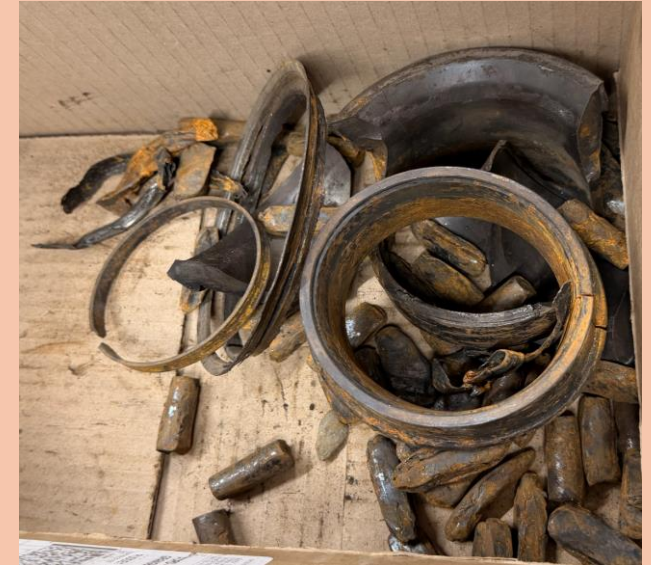
MAJOR DAMAGE (INTERNAL & EXTERNAL) CRITERIA:

- Brake disc seating lugs damaged or missing
- Severe damages to the casting
- Damage to the ABS seating area
- Collapsed or spun wheel bearing

NOT APPROVED! ❌
